# EVALUATION OF CONCRETE CORES FROM WATERBURY DAM, WATERBURY, VT.

Carl E. Pace, Richard L. Stowe, G. Sam Wong

September 1982

Final Report

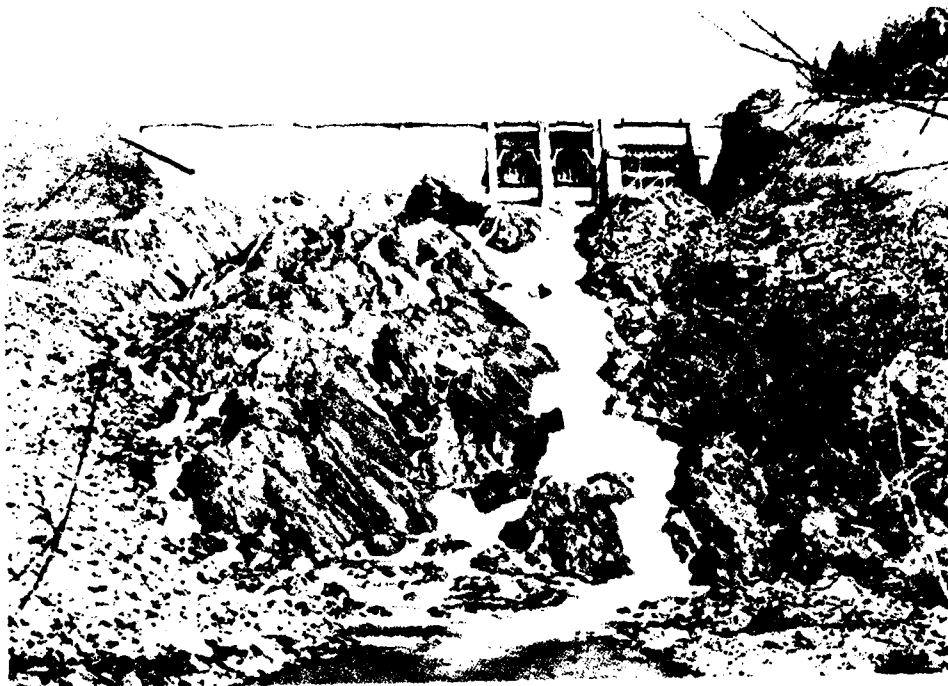
Figure 1. Spillway and outlet works, Waterbury Dam

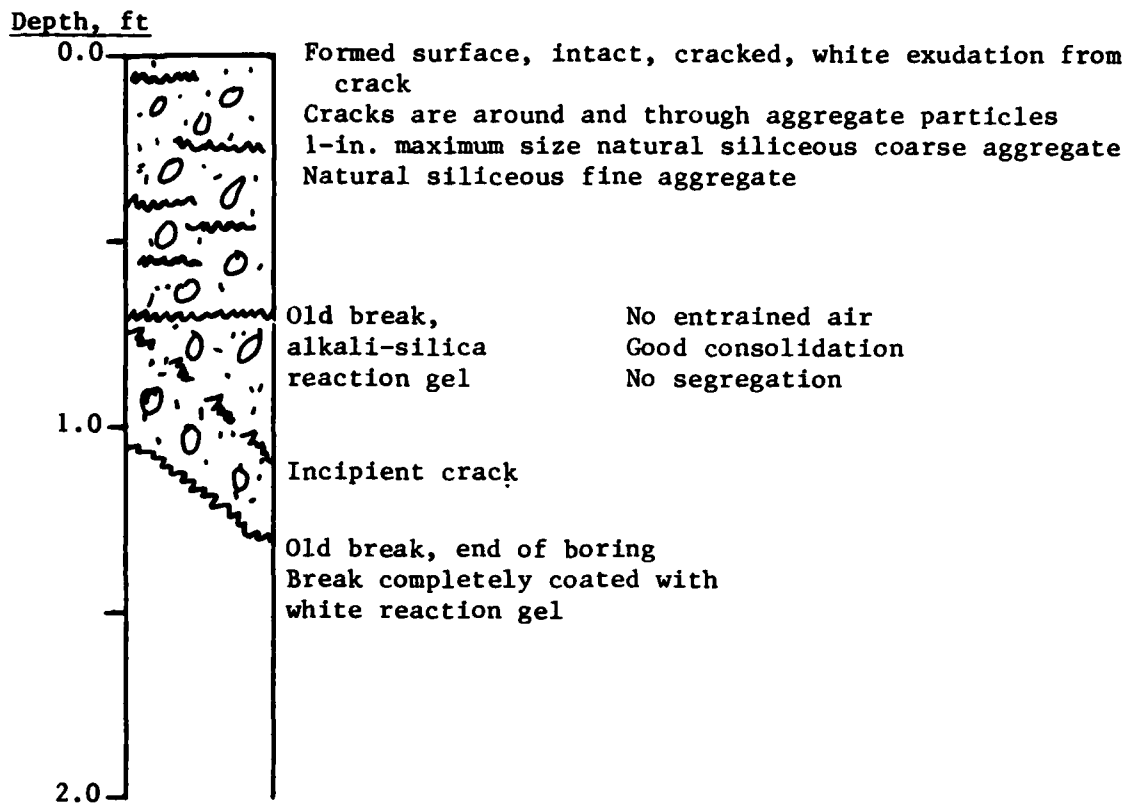
Figure 4. Waterbury Dam, New York District, 6-in.-Diameter Concrete Core NY-8 CON-2 from Spillway Section C

12, 3, 16, 18, 19, 21, and 23 to fractured and fragmented concrete illustrated by cores NY-8 CON-2, 5, 11, 14, and 15 (Figure 2). Other cores showed areas of poor consolidation and loose contact of new concrete with old concrete. The core logs (Figures 3-28) describe the nature of the cores received for examination. Maximum depth of deterioration was 1.4 ft as shown by core NY-8 CON-5.
